# Phase 1 Habitat Survey & Protected Species Assessment

Land to the rear of No 2,  
Harbury Street, Burton on Trent

Report Reference: BG14.236

October 2014

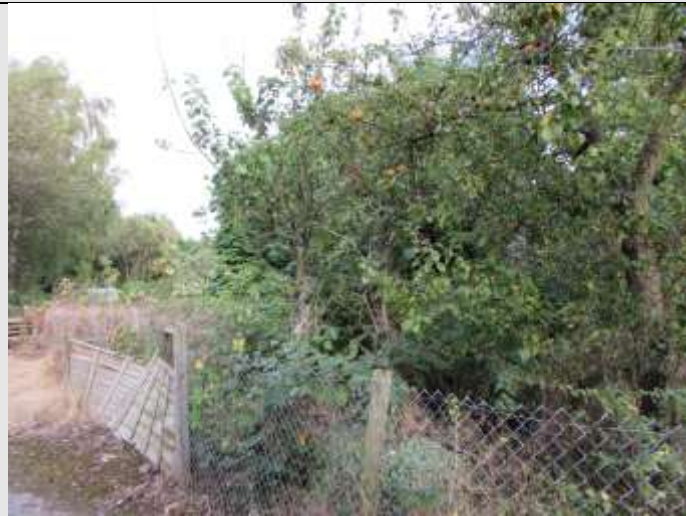
**Photograph 1**

Rear of Building 2.

Small allotment area containing rough scrub and immature apple trees.

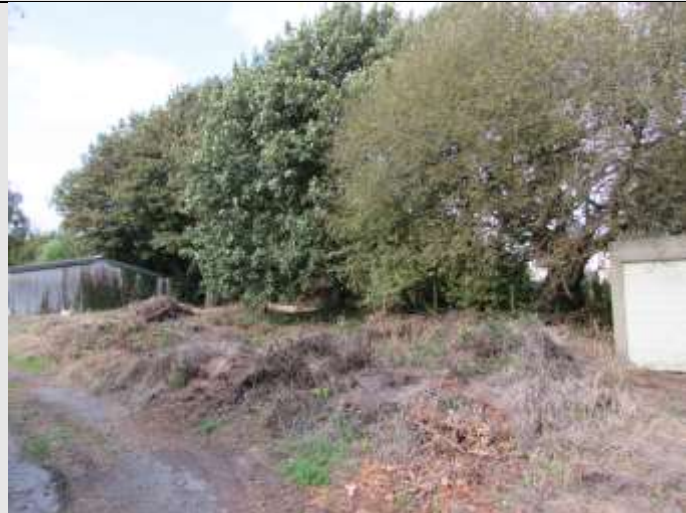
**Photograph 2**

Northern boundary

Rough scrub land and tree cuttings cover the area, with mature trees present.

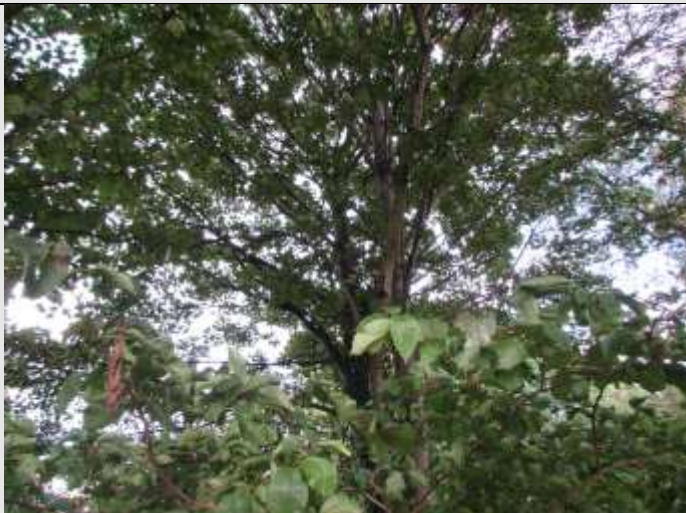
**Photograph 3**

Mature Sycamore (*Acer pseudoplatanus*) within the North of site.

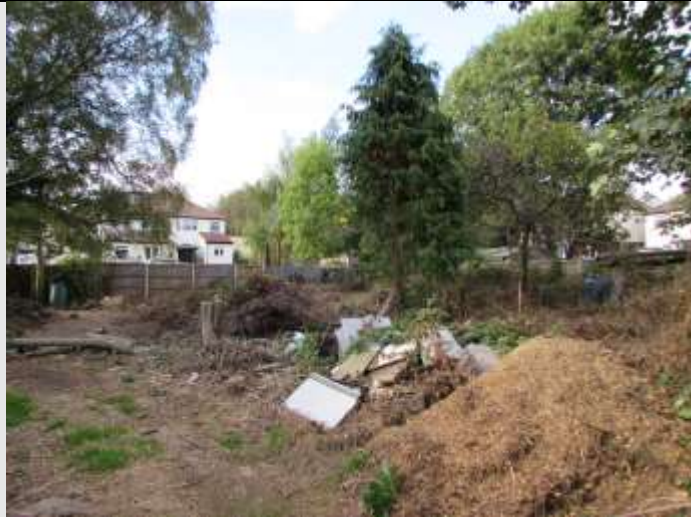
**Photograph 4**

Open area of the site where vegetation has been cleared.

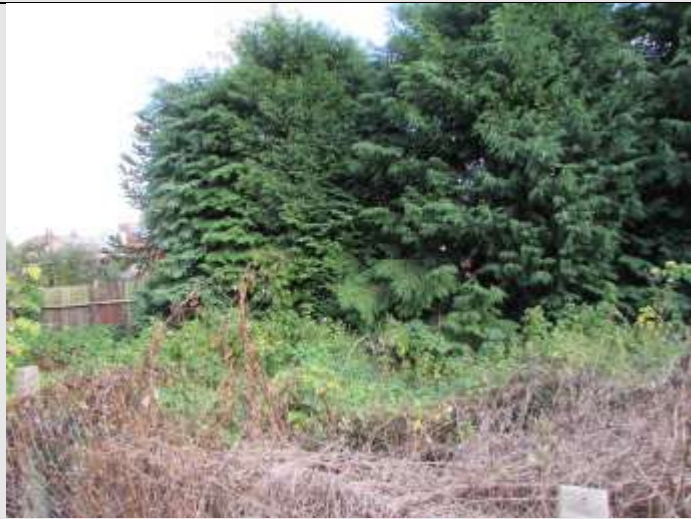
**Photograph 5**

NE of site  
Scattered scrub land with conifer trees.

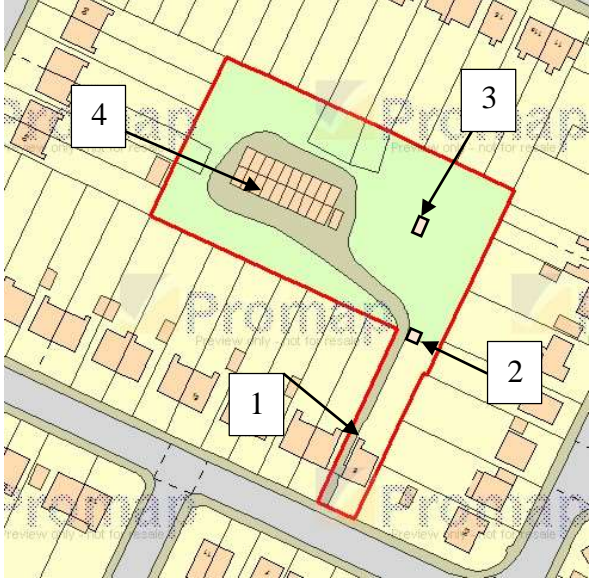
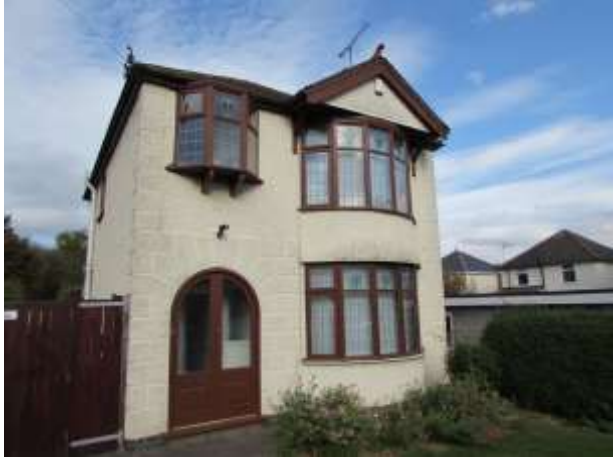
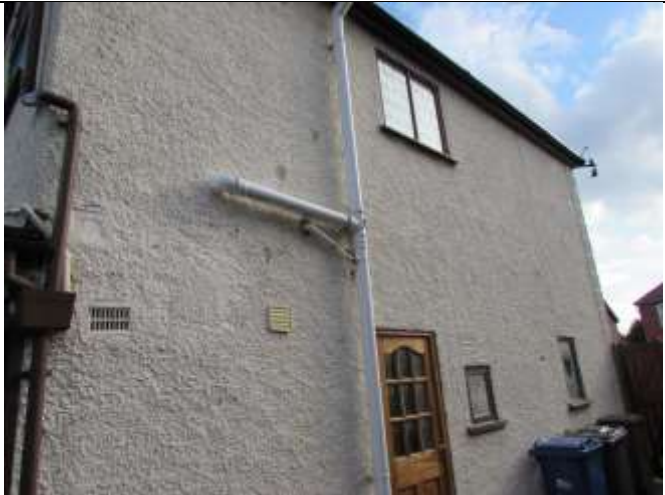
Building 1 is a two storey brick built building with a pitch tiled roof. The fascia boards fit flush to the elevations leaving no access points for bats. The roof is in good condition with no cracked or slipped roof tiles detected. An elevated survey of the roofing structure could not be undertaken safely on initial survey. The building is pebble dashed offering no brickwork that could harbour suitable refugia e.g. gaps / crevices.

<b>Building Number: Building 1</b>	
<b>Bat Risk Category:</b>	<b>Negligible</b>	<b>Layout/Photographs:</b>
<b>Building Description:</b>	<p>Two storey (northern end single storey) building.</p> <p>Roof structure/tiles in good condition.</p>

<b>Protected Species Evidence:</b>	<p><u>Bats</u></p> <p>No evidence of bats recorded.</p> <p>Internal inspection not achieved.</p> <p>No gaps between fascia and elevation recorded.</p>

Suitable gaps were not found along the edge of the roofs. However, Building 1 expressed areas of fascia board that had been damaged, offering potential refugia for roosting bats/ Cobwebs were present along all of these damaged areas indicating

that bats had not recently been using them. Bat dropping were not found in the vicinity.

<b>Recommendations:</b>	<p>Based on the external survey this building was awarded a negligible category, it must be noted however that an internal inspection could not be achieved at time of survey.</p>

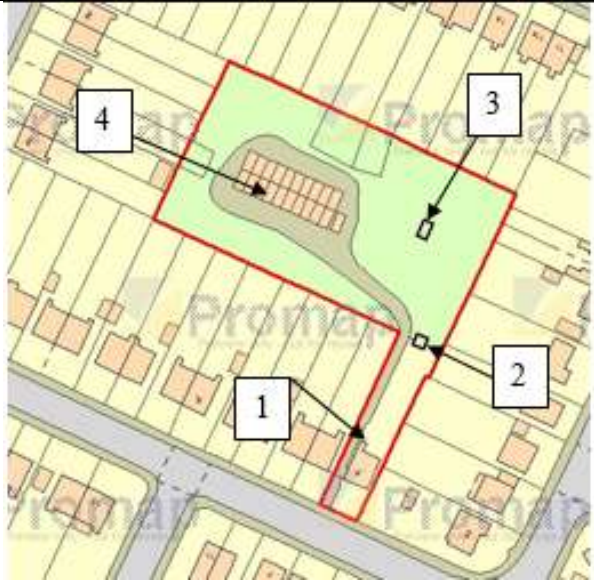
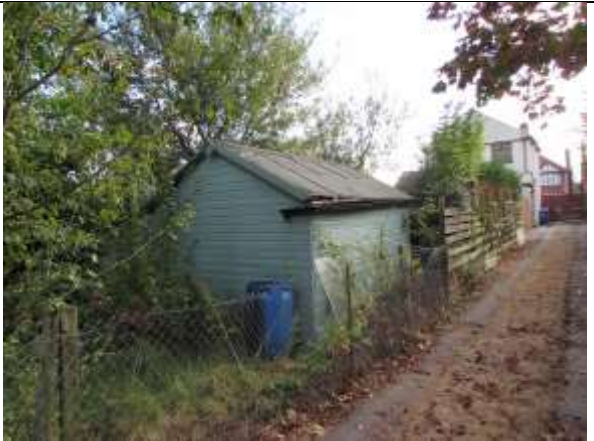
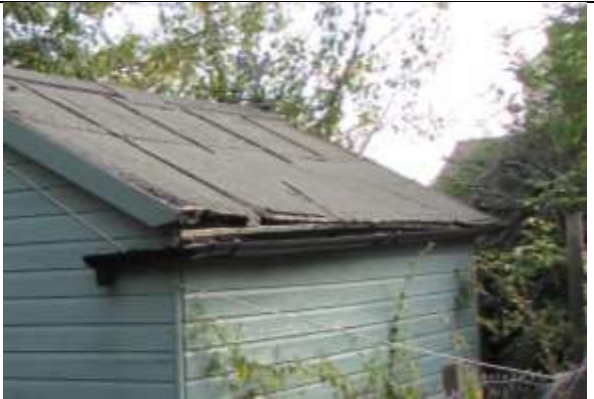
Building 2 is a small wooden shed with pinned felt roof. The building was in a poor state of repair with openings between roof and elevation limiting the buildings sheltering properties. The low elevation presents poor predator protections for roosting bats.

<b>Building Number: Building 2</b>	
<b>Bat Risk Category:</b>	<b>Negligible</b>	<b>Layout/Photographs:</b>
<b>Building Description:</b>	<p>Felt lined wooden shed.</p> <p>Felt tight and well-sealed.</p> <p>Building in well maintained condition.</p>

<b>Protected Species Evidence:</b>	<p><u>Bats</u></p> <p>No evidence of bats recorded.</p> <p>Internal inspection not achieved.</p> <p>Access points for bats seen however due to its state of repair and size, highly unlikely to be used by bats</p>

<b>Recommendations:</b>	<p>Although gaps existed externally on the structure that allow access for roosting bats, these are greatly exposed and would be mostly unattractive as bat refugia.</p> <p>No further surveys recommended.</p>

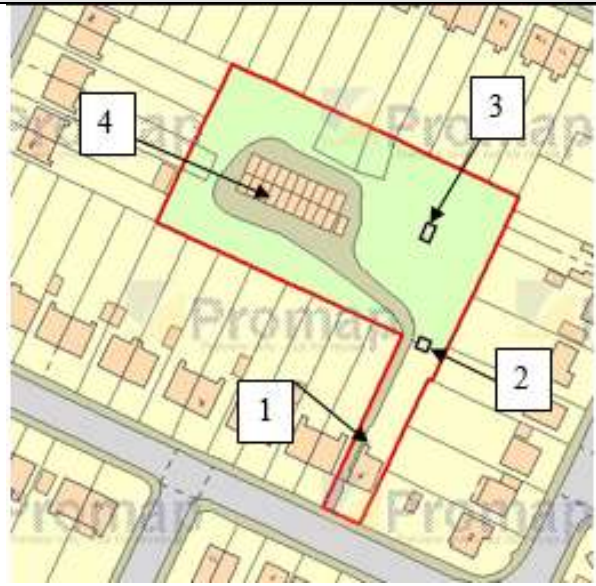
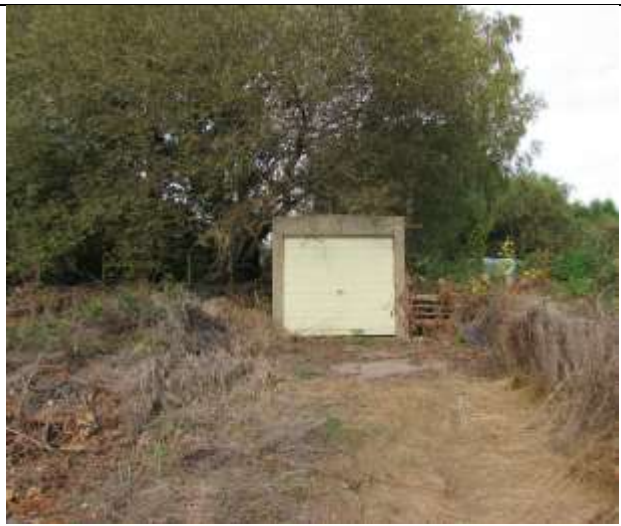
Building 3 is a small concrete and corrugated metal garage with a flat roof. The garage was sealed and tight however a small gap existed above the garage door. This building was small and heavily stored with tools and gardening equipment limiting its potential to support roosting bats.

<b>Building Number: Building 3</b>	
<b>Bat Risk Category:</b>	<b>Negligible</b>	<b>Layout/Photographs:</b>
<b>Building Description:</b>	<p>Small concrete and sheet metal garage.</p> <p>Building in an un-maintained condition.</p>

<b>Protected Species Evidence:</b>	<p><u>Bats</u></p> <p>No evidence of bats recorded.</p> <p>Internal inspection not achieved.</p> <p>Access point above door noted but due to the nature of the buildings construction, bat presence is unlikely.</p>

<b>Recommendations:</b>	<p>Although gaps existed externally on the structure that allow access for roosting bats, these are greatly exposed and would be mostly unattractive as bat refugia.</p> <p>No further surveys recommended.</p>

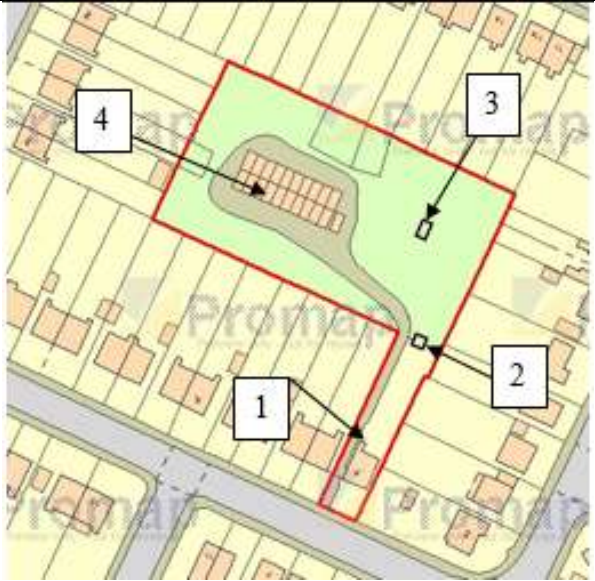
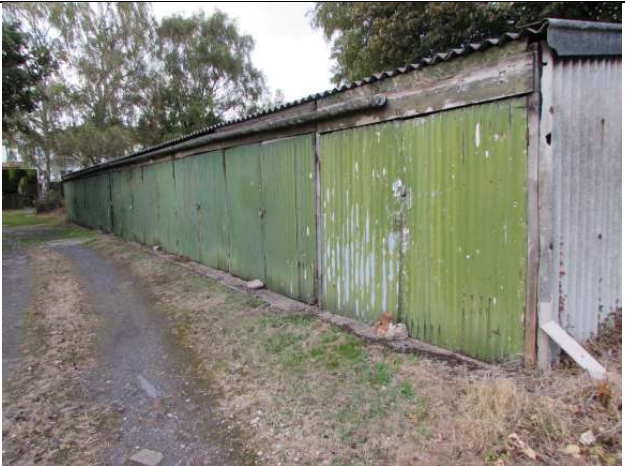
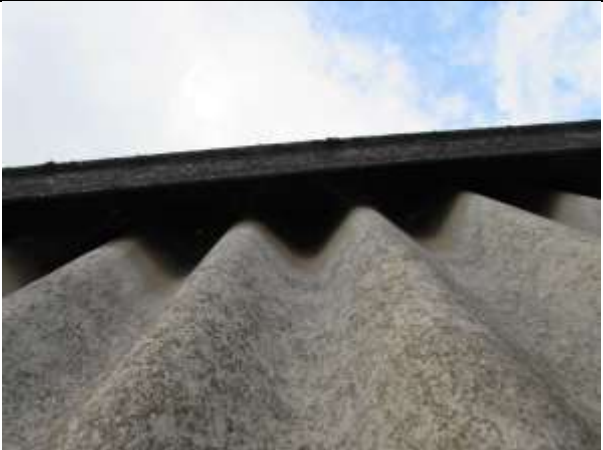
Building 4 was a large single storey block of garages made of corrugated material with corrugated metal doors, the building was in a poor state of repair with damaged and holes in the elevations around the structure, fascia boards were fitted around the building flush to the elevations offering no potential refugia for roosting bats. The presence of ivy was also seen growing on the building.

An internal inspection of the building could not be undertaken at the time of the survey. However the interior could be seen through holes in the exterior elevations and the roof was made up of corrugated sheets bolted directly to metal beams offering no sheltered bat refugia opportunities.

<b>Building Number: Building 4</b>	
<b>Bat Risk Category:</b>	<b>Negligible</b>	<b>Layout/Photographs:</b>
<b>Building Description:</b>	<p>Corrugated material structure comprising of 20 garages.</p> <p>Edges tight and well-sealed.</p> <p>Building in an unmaintained condition.</p>

<b>Protected Species Evidence:</b>	<p><u>Bats</u> No evidence of bats recorded.</p> <p>Internal inspection not achieved.</p> <p>Access points seen but due to the nature of the buildings construction, bat presence is unlikely.</p>

<b>Recommendations:</b>	<p>Although crevices existed externally on the structure that could house roosting bats, these are greatly exposed and would be mostly unattractive as bat refugia.</p> <p>No further surveys recommended.</p>

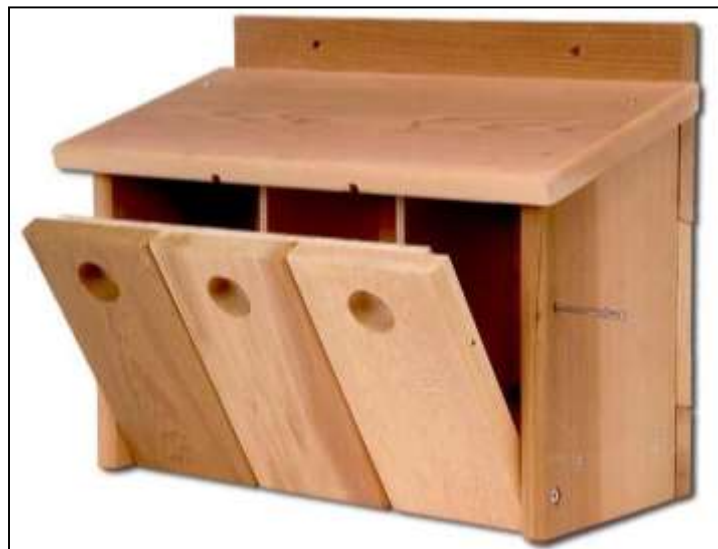
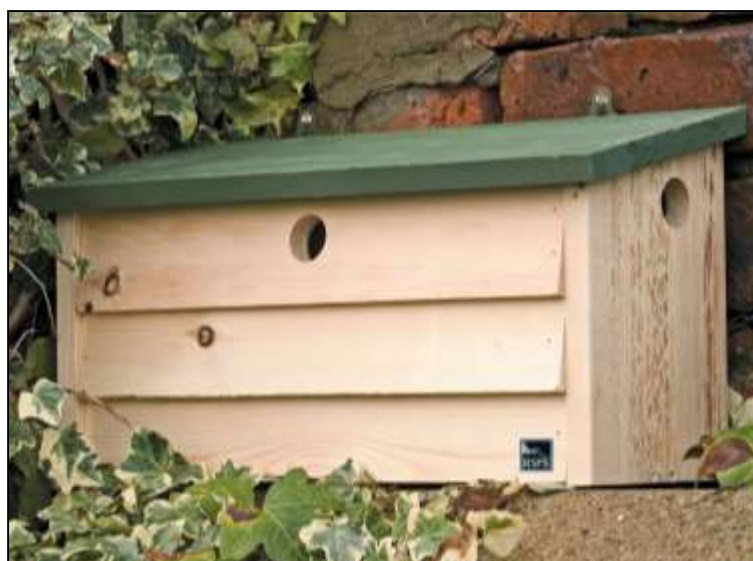
House sparrow nest box designs. Suitable for mounting on all building structures.

The site, with its location and set proposals, presents itself as an ideal candidate to undertake simple House sparrow conservation endeavours. This species is RSPB red listed due to an estimated 71% decline nationally across both urban and rural environments. The erection of sparrow specific design nest boxes would express well considered ecological enhancement measures and be viewed positively in light of the NPPF (2012) which seeks biodiversity enhancements through the planning process. See below for potential House sparrow nest box designs. Such nest boxes are widely available.
