Former Burton Day Centre

Bat and Bird Daytime Scoping Survey Report

December 2017

Former Burton Day Centre, Waverley Lane, Burton-on-Trent, Staffordshire, DE14 2HF

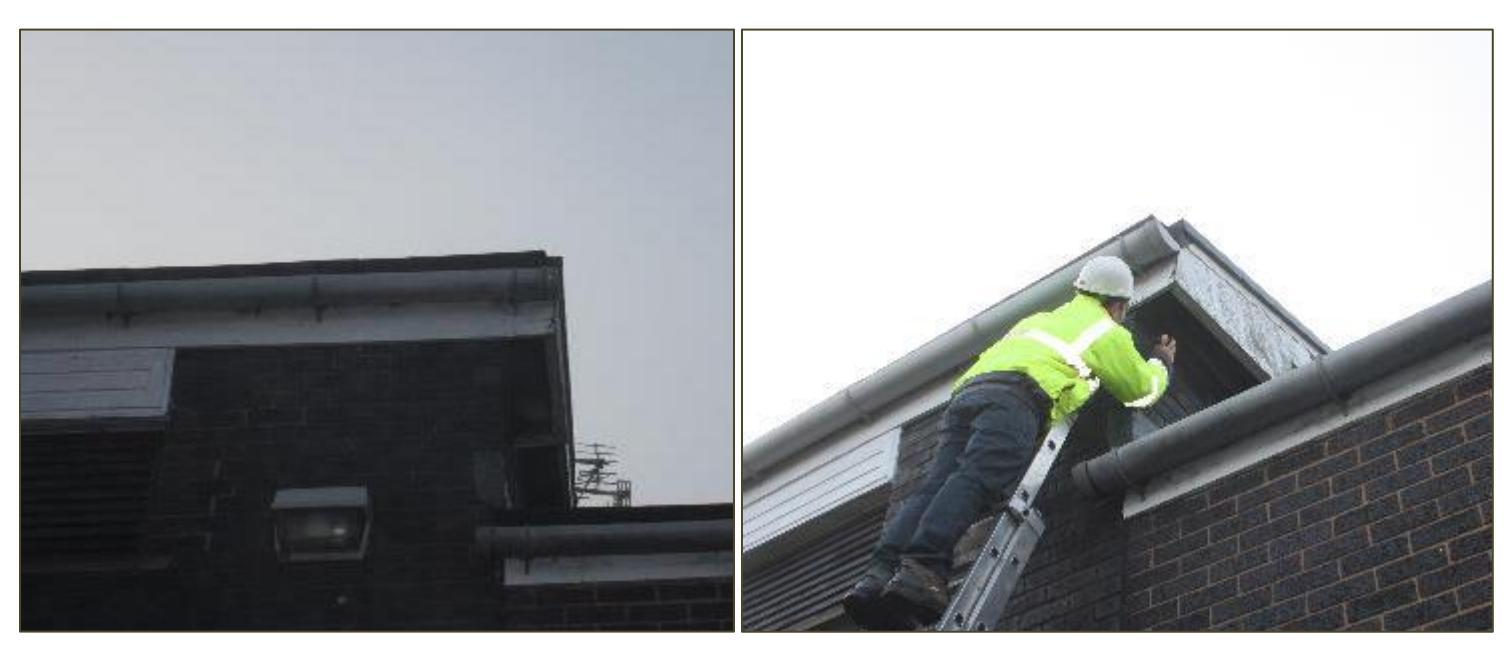
Hotspot Area 1, was situated on the northern and western elevation of the boiler room section of the building. The soffit board had a gap and was inspected by the ecologist. During this inspection, an accumulation of cobwebs was present, indicating that no bats or birds have been using this feature for roosting or nesting.

Figures 2 & 3: Photographs of 'hotspot area 1' that was inspected in further detail.

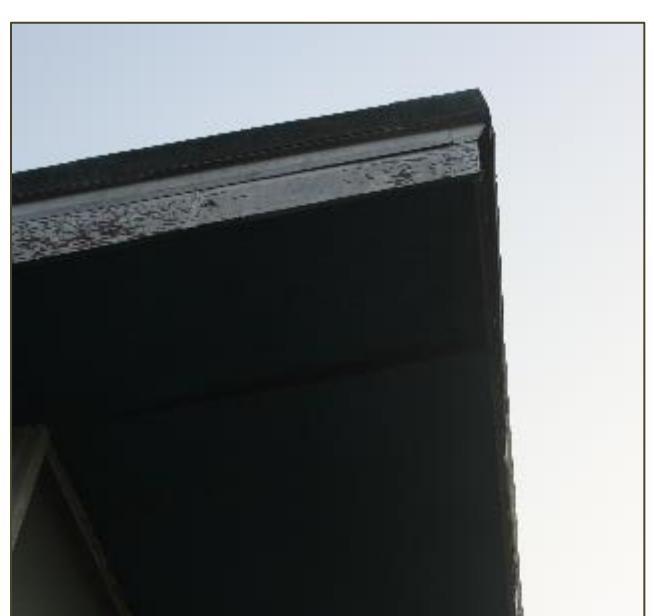
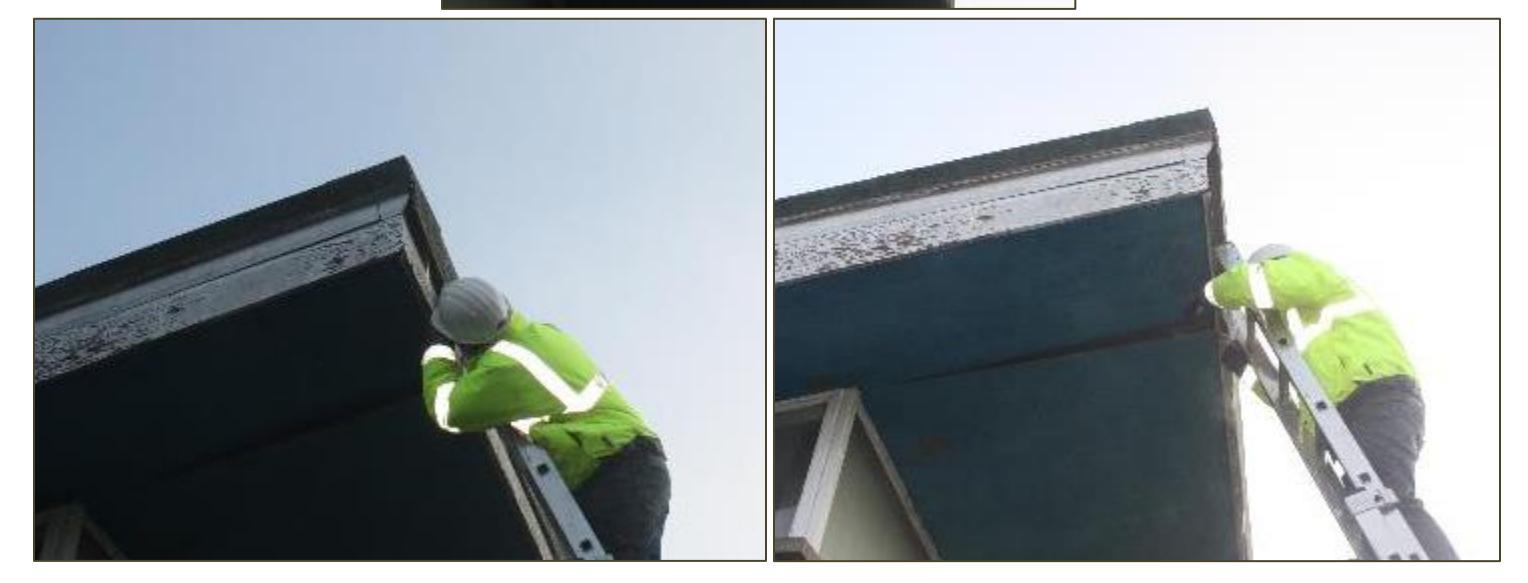
Hotspot Area 2, was situated on the southern elevation of the building, where gaps were present around the fascia/soffit box. During this inspection the gaps were found to either be an insufficient size, or an accumulation of cobwebs were present, indicating that bats and birds had not being using this feature for roosting or nesting.

Figures 4, 5 & 6: Photographs of 'hotspot area 2' that were inspected in further detail.

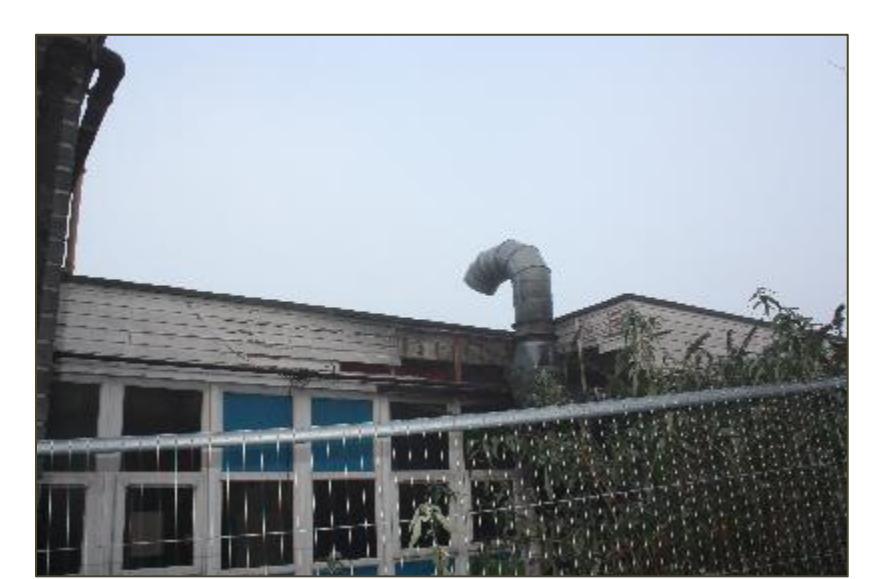
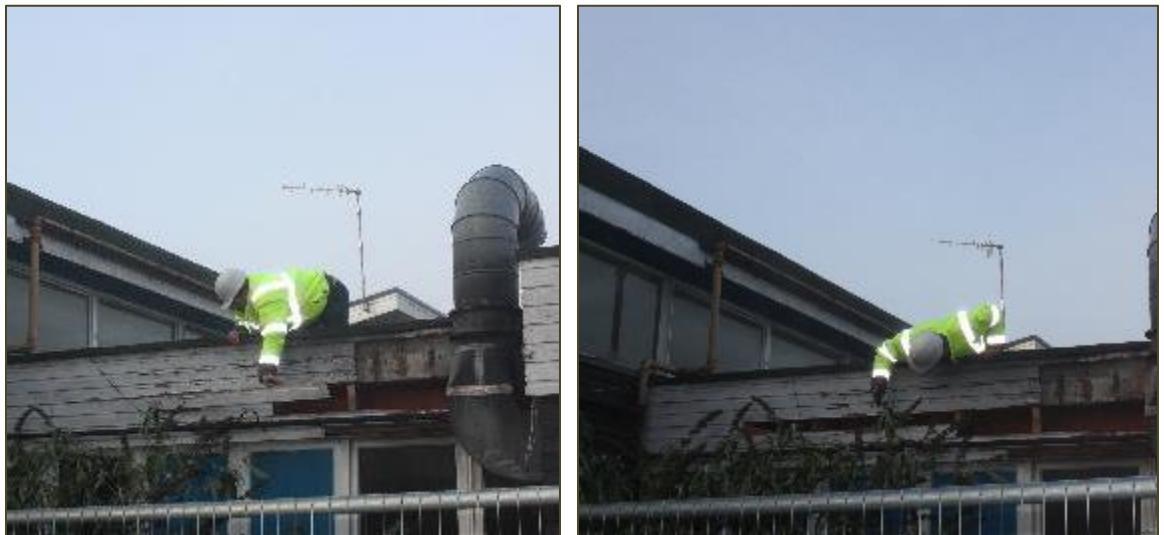
Hotspot Area 3, consisted of a section of the fascia board that had become missing on the eastern elevation. This feature was thought to be very exposed to the weather elements and once again contained an accumulation of cobwebs, indicating that bats and birds had not being using this feature for roosting or nesting.

Figures 7, 8 & 9: Photographs of 'hotspot area 3' that were inspected in further detail

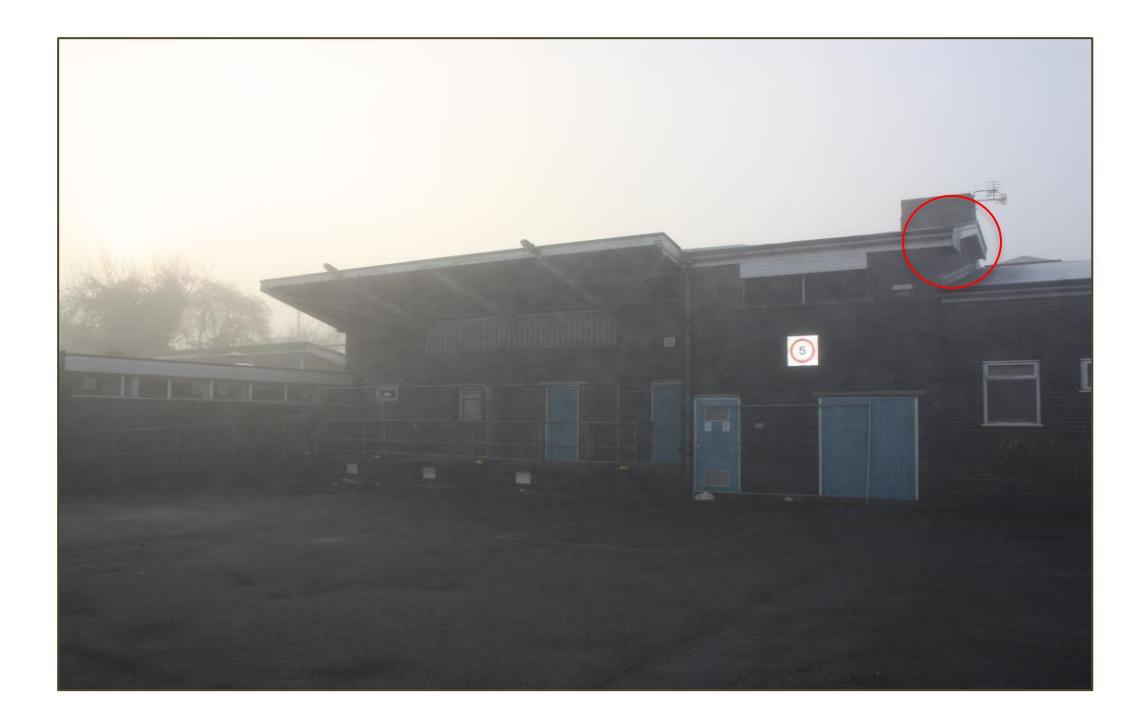
Plate 2: A photograph of the northern elevation of the structure. (Hotspot Area 1, is indicated by the red circle)

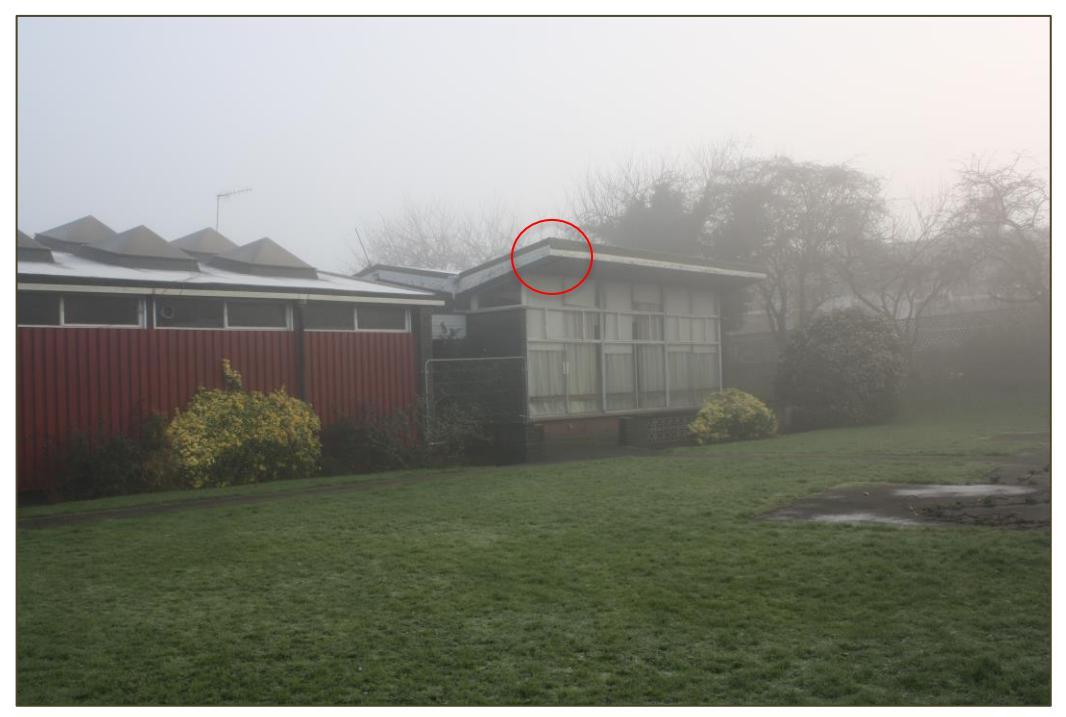
Plate 4: An image of the southern elevation of the building (Hotspot Area 2, is indicated by the red circle)

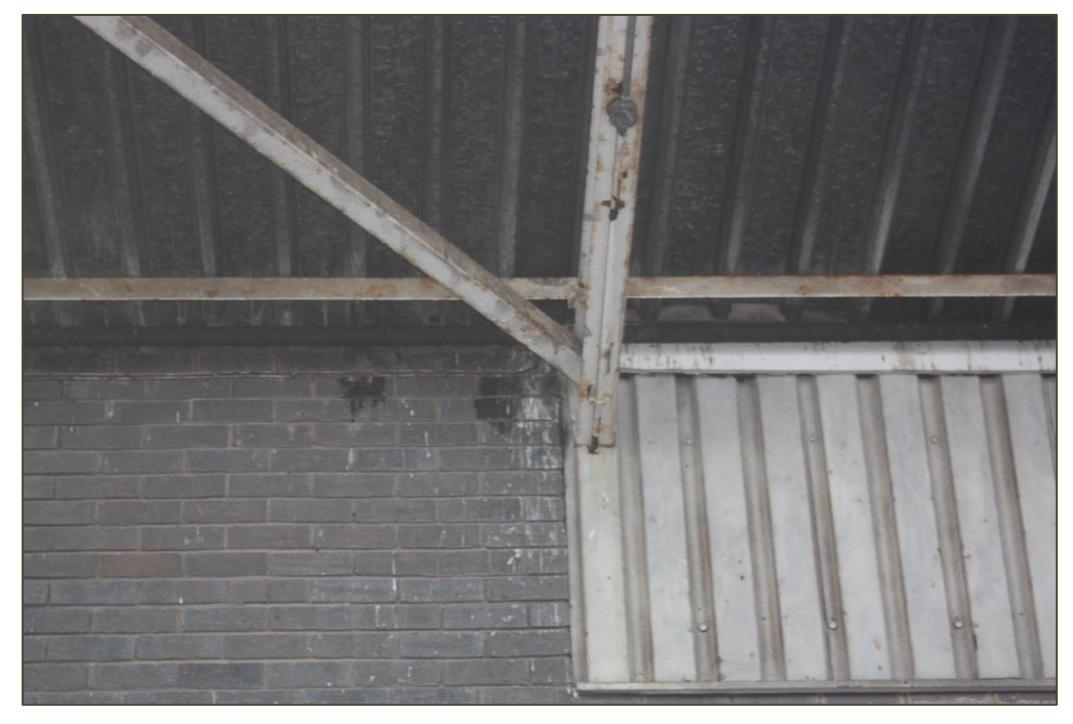
Plate 6: An image showing some of the whitewash (bird droppings) on the walls of the building where a woodpigeon (*Columba palumbus*) nest is located.

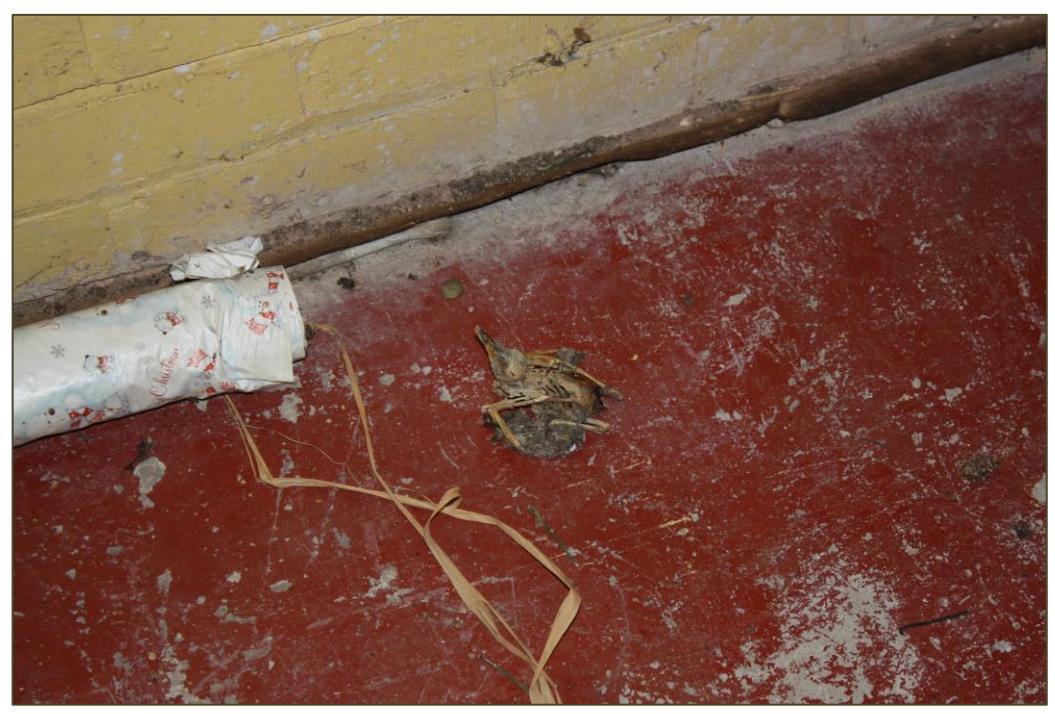
Plate 8: An image showing the deceased woodpigeon (*Columba palumbus*) chick in the building.

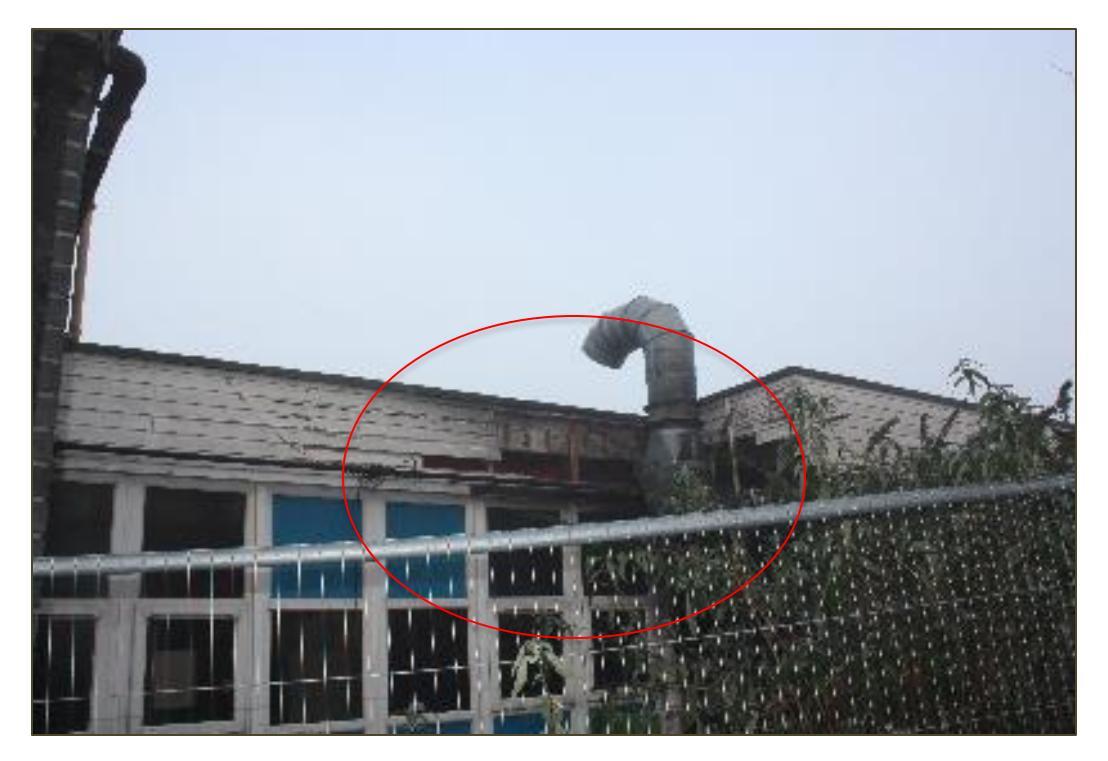
Plate 9: An image showing the east elevation of the building (Hotspot Area 3, is indicated by the red circle)
